Technical Guide.

Case study: Premature wearing of the outer pad.

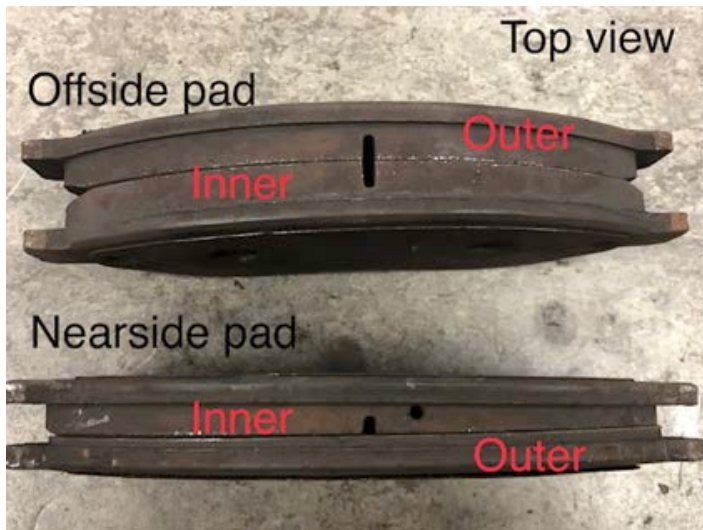
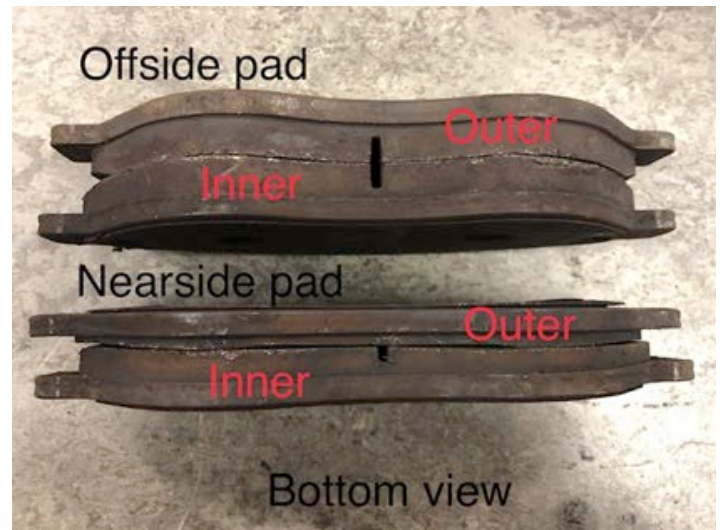
This issue had spanned over a few months. It had started with the owner of the vehicle purchasing the vehicle and requesting for the brakes to be replaced. A few months after the brakes were replaced the owner reported of squealing noises at low speeds as well as a burning smell. Upon removing the front discs and pads, they discovered that the NSF outer (or finger side pad) had worn down considerably more than the inner pad.

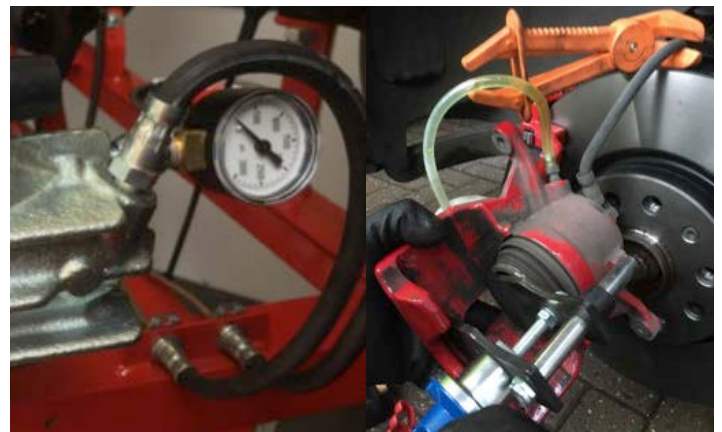
As all components have been proven to move freely when disconnected from each other, Techmate suspected the possibility of a component that could be misaligned. Due to this misalignment, it would prevent the outer pad from returning. To confirm that the brake disc is in alignment, a run out measurement was taken to eliminate the brake disc as a source of misalignment. For this vehicle, the manufacturer's recommended maximum amount of tolerance for brake disc runout is 0.05mm. The runout reading was 0.04mm which eliminates the brake disc.

The other source of misalignment is the brake carrier, should this be misaligned, would be positioned in an angle that would prevent the outer brake pad from returning. To confirm this, a feeler gauge was used to measure the gap between the disc and the carrier and

compared the differences between the nearside and offside. By measuring, this confirms that there is a definite difference in measurement between the two. With the caliper bolted on to further confirm the misalignment, the nearside caliper kicks out slightly indicating a misalignment rather than moving laterally when the brakes are applied.

The carrier was replaced curing this issue and Techmate was delighted to have assisted to resolve the issue. If you ever have any questions, please feel free to contact our technical helpline on 01174 288100. Apec Braking is proud to provide you with technical information to support the quality of its products and to uphold its "Full Spec. Full Stop." promise to customers.
