Technical Bulletin.

Discs with ABS Rings.

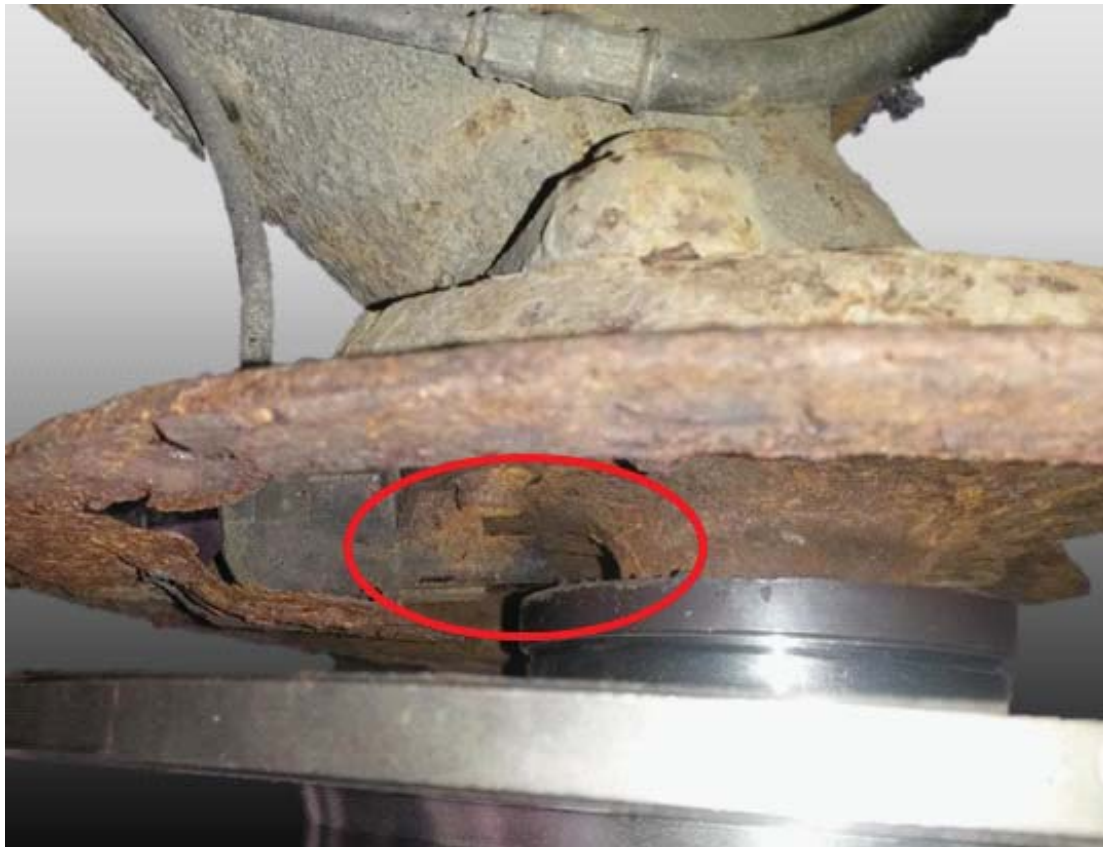
When fitting a new disc that has the ABS ring attached, you may find that the ABS ring on the new disc touches the ABS sensor. This is because corrosion has built up under the ABS sensor mounting point causing the sensor to be pushed towards the disc and wearing the top of the ABS ring on the old disc.

The solution is to remove the ABS sensor from its mounting point and remove any corrosion before refitting the ABS Sensor and new disc.

Similar issues arise with ABS sensors that are fitted in to guide tubes. To remedy the issue, remove the ABS sensor and clean the tube with a suitable reamer.
