DISCS WITH ABS RINGS: ABS SENSOR ISSUE

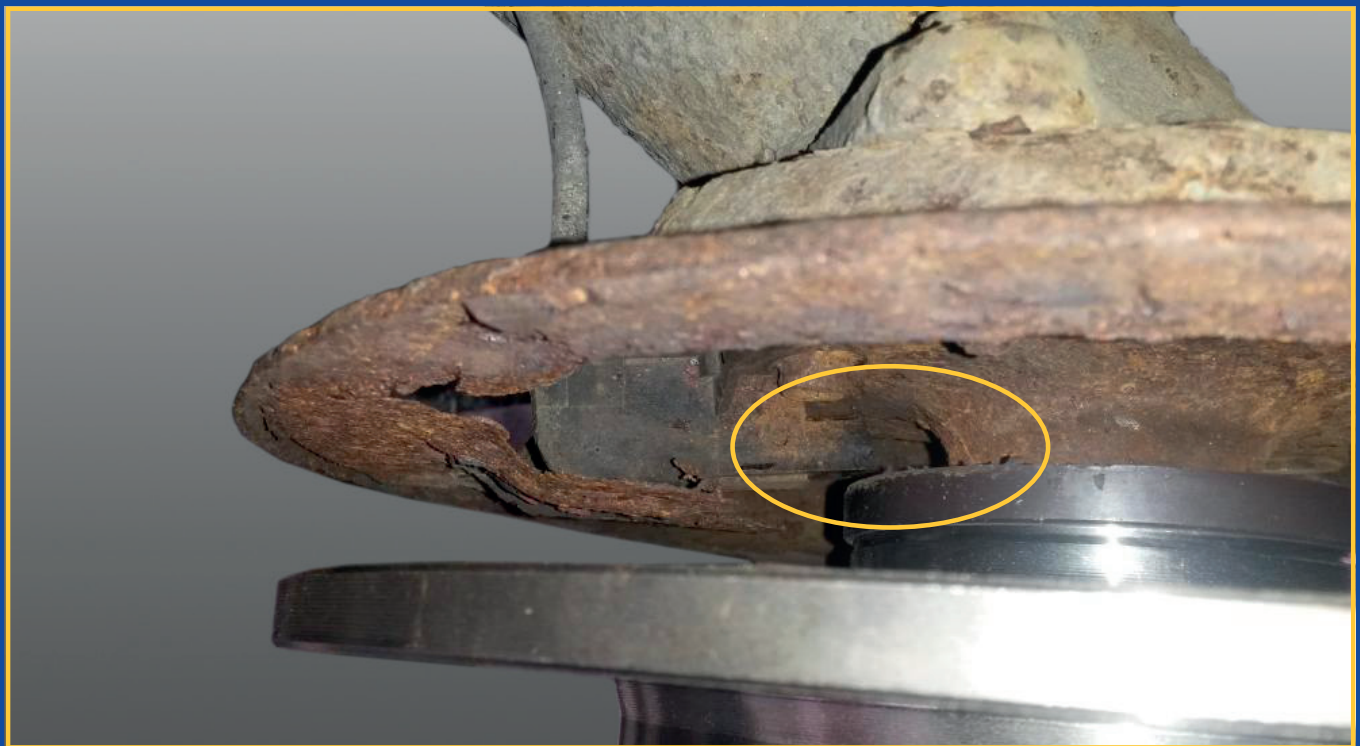
When fitting a new disc with an ABS ring, the ring might touch the ABS sensor as corrossions have built up under the mounting point, causing it to be pushed towards the disc.

To fix this issue, remove the ABS sensor from its mounting point and remove the corrosion before refitting the sensor and the new disc.

Similar issues may arise with ABS sensors that are fitted in guide tubes which can be remedied by removing the ABS sensor and cleaning with a suitable reamer.
