Technical Guide.

Brake Judder – Preventative Steps.

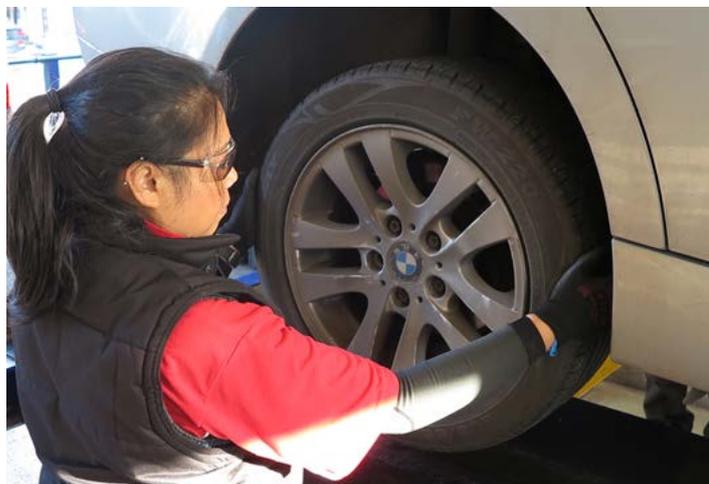
- Test drive the vehicle prior to removal of any parts to confirm any symptoms.
- Visually inspect the tyres. Uneven tyre wear, radial separation and damage to the tyre are causes of symptoms that can sometimes be mistaken for brake related issues.
- Check the condition of the wheel bearings. A worn bearing can also cause excessive lateral runout, which may cause the brakes to pulsate or pull.
- Examine the steering and suspension bushes and joints for any free play. Worn steering and suspension bushes will not be able to absorb vertical and lateral forces produced by the vehicle when braking and can cause juddering.

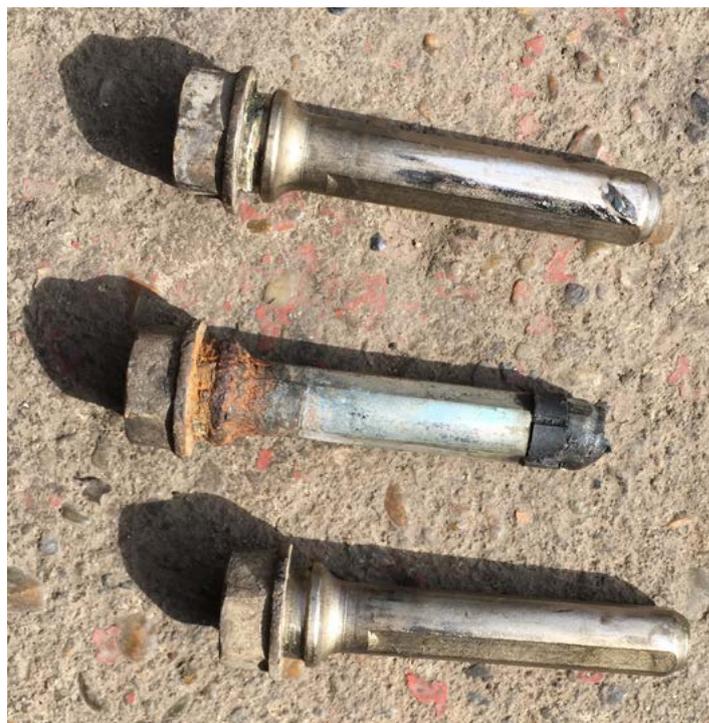
- Check that the pads can move freely in the caliper carrier, corrosion build up can cause the pads to seize. *
- Inspect the caliper fingers and piston contact points, excessive corrosion can cause misalignment of the pads. *
- Completely remove the caliper to enable inspection of both caliper sliders. Deteriorated sliders and rubber boots can prevent free movement. If in doubt of their condition, please renew. *
- Manually retract the caliper pistons to check for free movement. *
- Measure the brake discs, using a micrometre, in at least 8 different equidistant points around its perimeter, 2.5mm from the outer edge. A brake disc with that exceeds the manufacturer's

tolerances (see note overleaf) of thickness variation will result in brake torque variation resulting in brake judder.

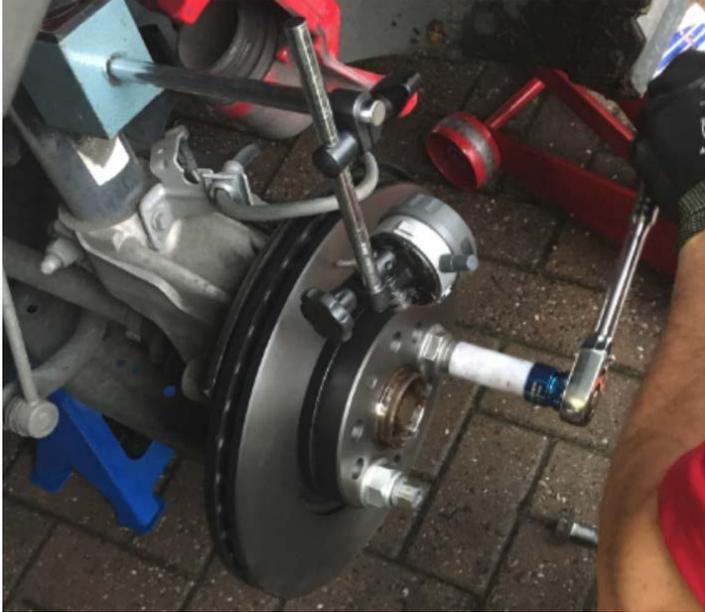
- Brake discs must always be replaced as an axle set to ensure consistency in braking.
- Clean the disc and mounting surface to ensure that it is clean. A foreign object, trapped between the mounting surface of the disc and the hub will cause excessive lateral runout, leading to excessive DTV and eventually brake judder.

- If equipped with a disc locating screw renew and replace. The screw secures the brake disc and prevents contamination entering behind the brake disc.
- Mount & secure the disc and check for disc run out using a DTI gauge, this should be no more than the vehicle manufacturer's tolerances. If the manufactures' data is unavailable, please refer to the following guide.

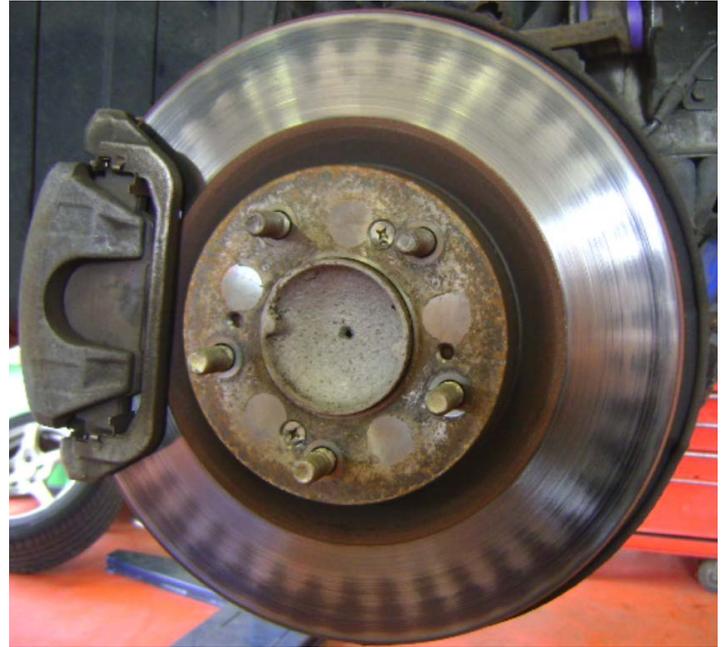
- Make the driver aware of the recommended "after care" for about 200 miles to ensure even material transfer.

- Even after 200 miles incorrect braking technique will affect the even material transfer process. Repeated heavy braking after high speeds, depressing the brake for long periods of time while stationary (when brakes are hot), continuous braking on steep declines instead of engine braking and feathering the brake pedal can disrupt the even material transfer process and cause DTV leading to brake judder.
